Facility Condition Index Report

Airport Hangar 1

City of Silver Bay Comprehensive Plan

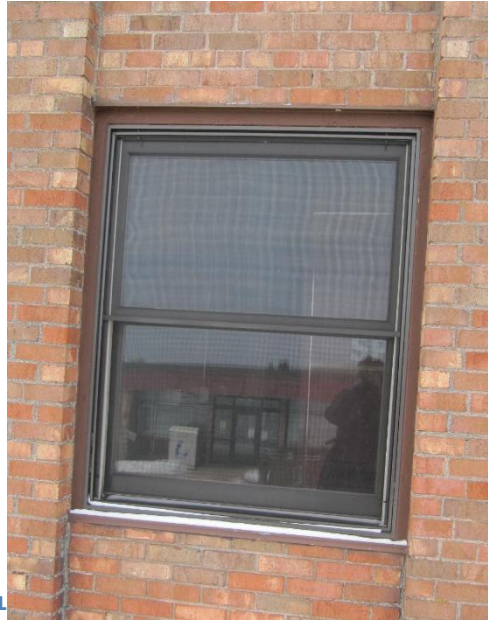
- B. **B2020 – Exterior Windows:** System was installed in 1986. Renewal Cost: \$4,728.

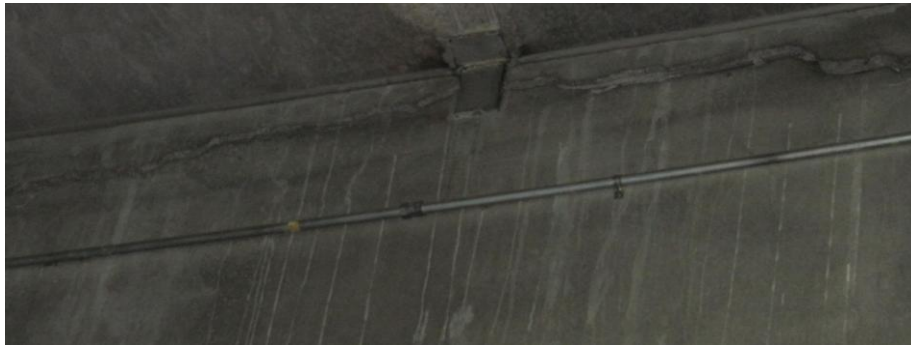
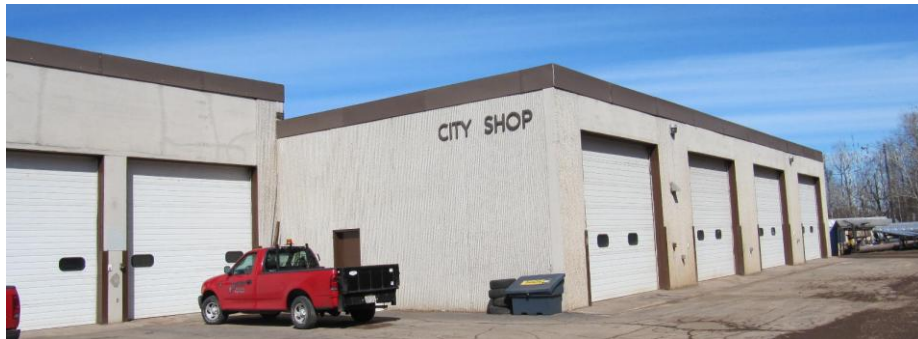
- B. **B10 - Superstructure:** System was installed in 1978. There are signs of inadequate subsurface soil bearing capacity. It is causing movement and premature failure of the structural wall system. It is recommended that a study be conducted to determine the type of repair that is needed to fix this deficiency. Structural Integrity Study Cost: \$5,800

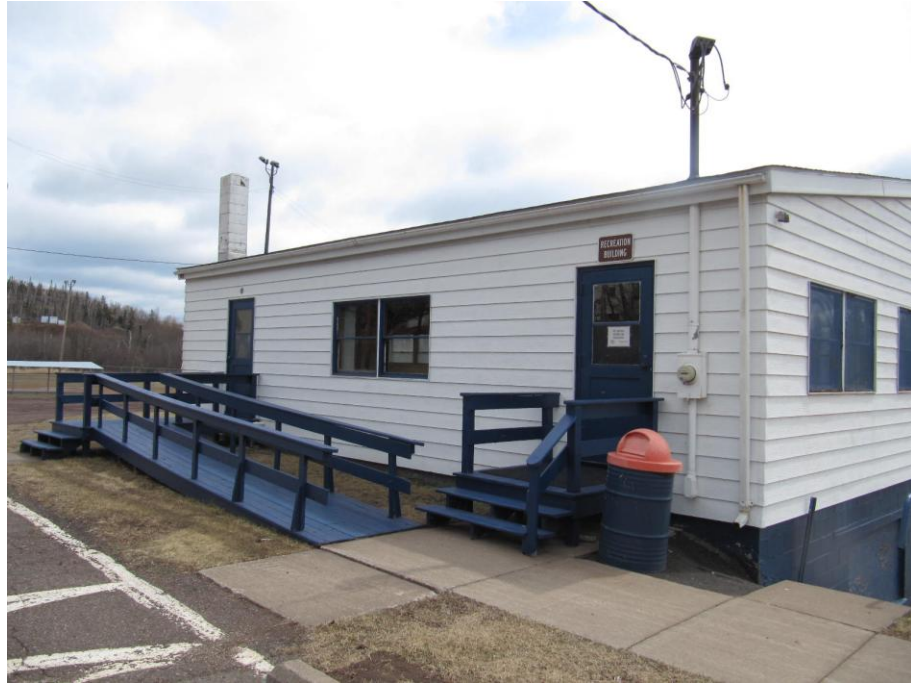
- B. **B2030 – Exterior Doors:** System was installed in 1950. Renewal Costs: \$ 9,769.

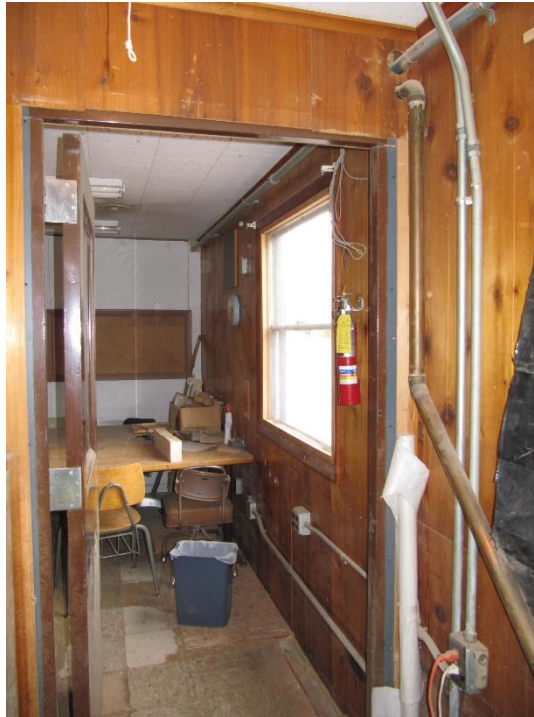
- A. **B2030 Exterior Doors:** system installed in 1988. Renewal costs: \$8,320.
- B. **B2020 – Exterior Windows:** System was installed in 1988. Renewal Cost: \$6,405.

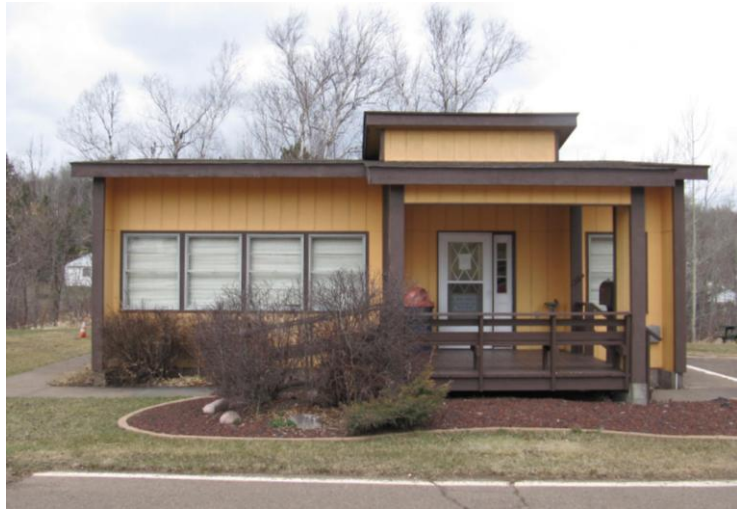
- A. **B2030- Exterior Doors:** System was installed in 1981. Renewal Costs: \$9,769.
- B. **B2020 – Exterior Windows:** System was installed in 1981. Renewal Cost: \$3,359.

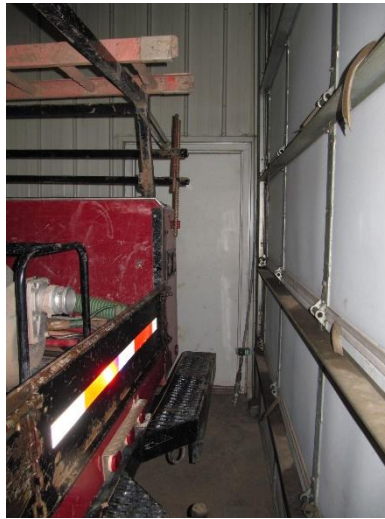
- A. **B2020 – Exterior Windows:** System was installed 1982. Renewal Cost: \$5,733.
- B. **B2030 Exterior Overhead Sectional Doors:** System was installed in 1982. Renewal costs: \$13,914.

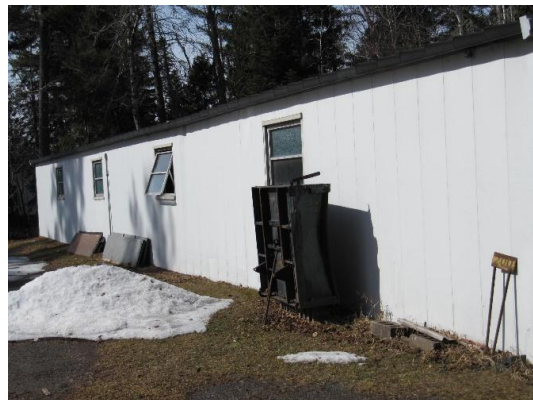
- A. **B2020 – Exterior Windows:** System was installed in 1957. Renewal Cost: \$4,300.

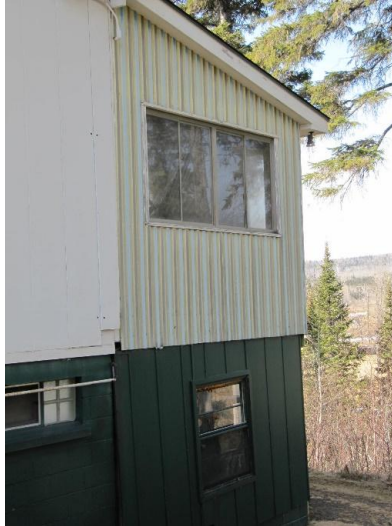
- A. **B2010 Exterior Walls:** Wood and metal siding was installed in 1957 and are in poor condition. Glass block was installed in 1957. Renewal Cost: \$3,070.

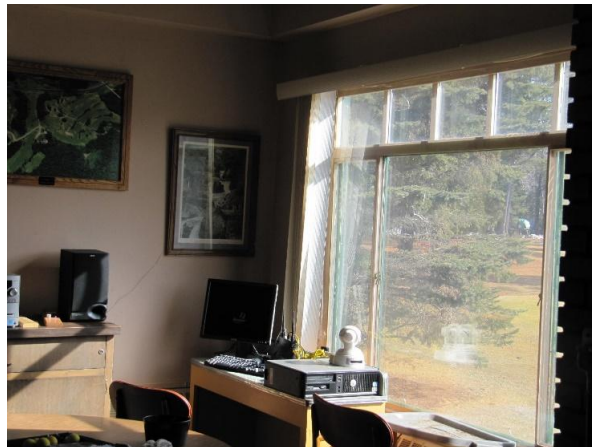
- B. **B2020 – Exterior Windows:** System was installed in 1957 and 1990 and is in poor condition. Renewal Cost: \$44,818.

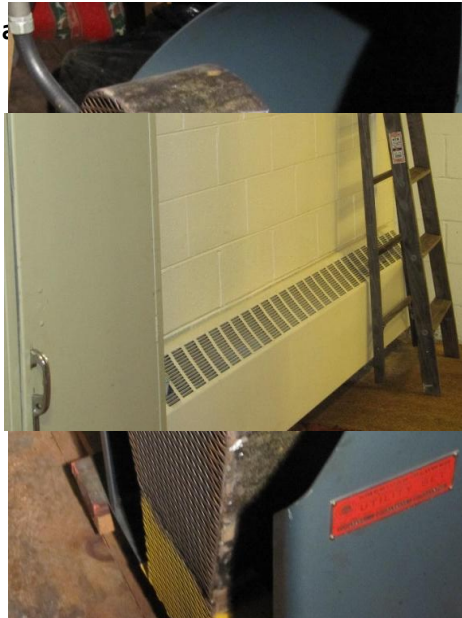
G. **D3040 – Perimeter Heating System:** System was installed in 1957. Renewal

Cost: \$ 52,436.

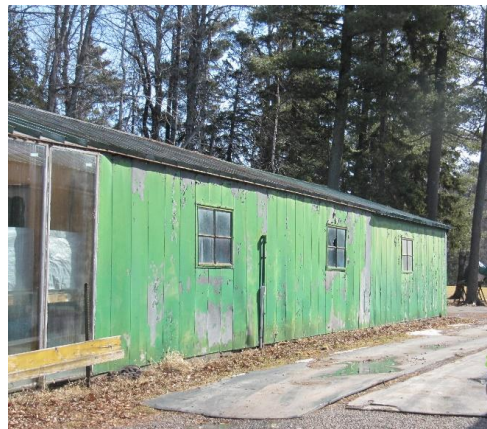
- A. **B30 - Roofing:** Metal roof System was installed in 1957 and is in poor condition. Renewal Cost: \$14,729.
- B. **B2020 – Exterior Windows:** Metal windows and translucent panels were installed in 1957 and are in poor condition. Renewal Cost: \$7,287.
