# City of Silver Bay Comprehensive Plan

## Building Data Summary

### City of Silver Bay Buildings Summary

Reporting Date: June 20, 2015

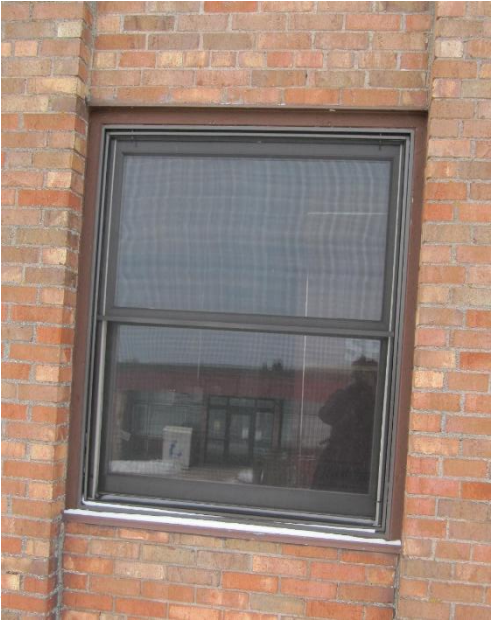
B. **B2020 – Exterior Windows:** System was installed in 1986. Renewal Cost: \$4,728.

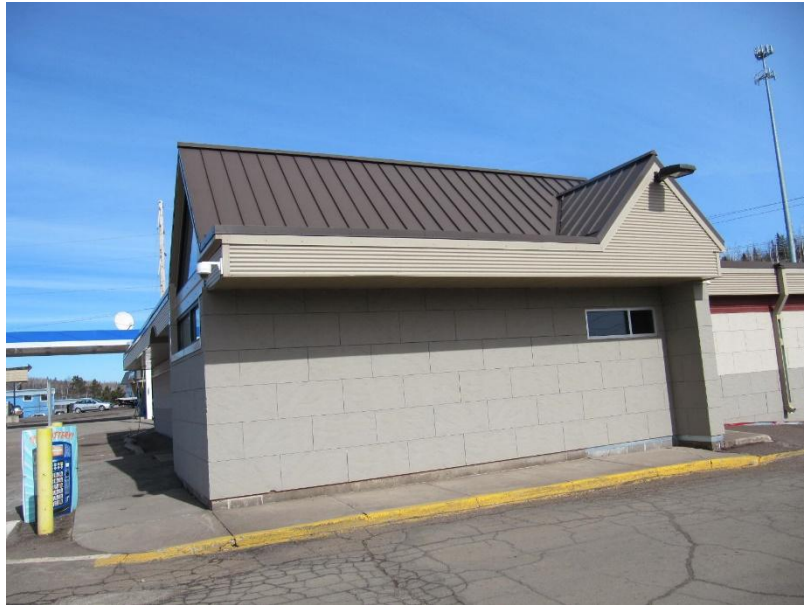
- A. **B30 - Roofing:** The system that was installed in 1977 is in poor condition. Supporting documentation of past repairs or roof replacement were not available. Renewal Cost: \$107,867.
- B. **B2020 – Domestic Water Distribution:** System was installed in 1977, both distribution system and water heater and are in poor condition. Renewal Cost: \$24,102.

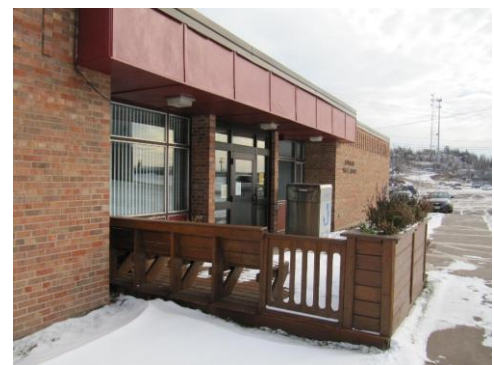
- A. **B30 - Roofing:** Current System was installed in November 1989 and is in poor condition. Supporting documentation of past repairs or roof replacement was not available. Renewal Cost: \$45,196
- B. **B2020 – Domestic Water Distribution:** System was installed in 1967 and is in poor condition. Renewal Cost: \$20,261

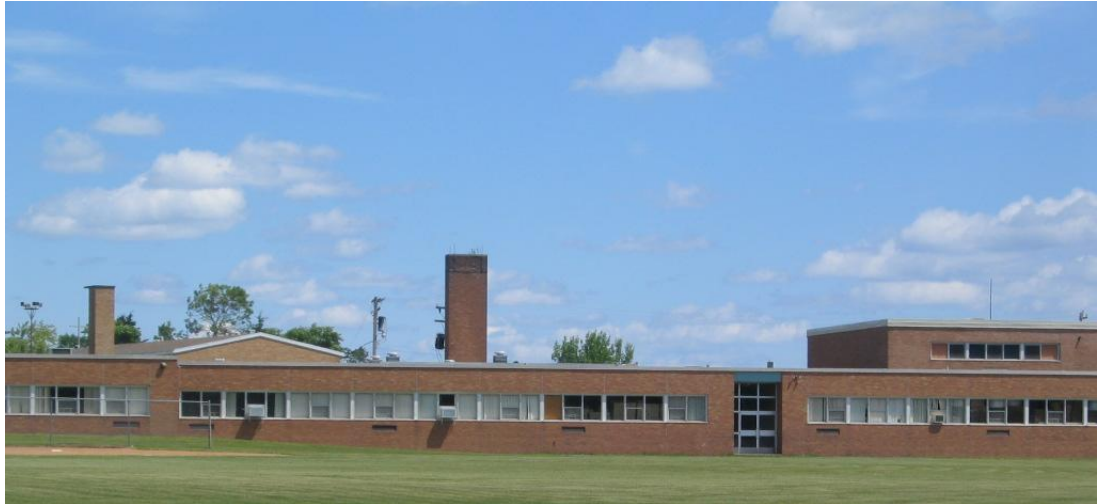
- A. **B30 - Roofing:** System was installed in 1962 with numerous repairs and is in poor condition. Supporting documentation of past repairs or roof replacement were not available. Renewal Cost: \$1,029,345.

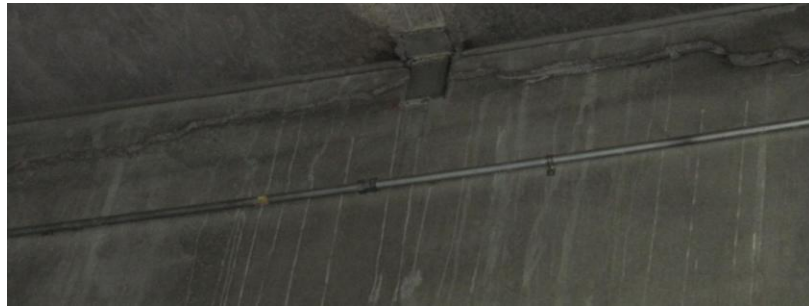
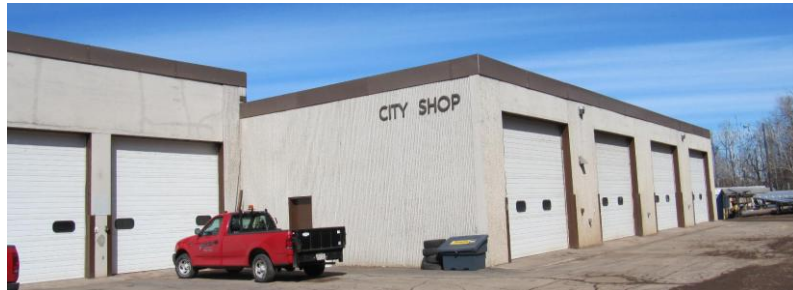
- B. **B10 - Superstructure:** System was installed in 1978. There are signs of inadequate subsurface soil bearing capacity. It is causing movement and premature failure of the structural wall system. It is recommended that a study be conducted to determine the type of repair that is needed to fix this deficiency. Structural Integrity Study Cost: \$5,800

- C. **D3040 – Exhaust Distribution System:** System was installed in 1978. Renewal Cost: \$55,479.

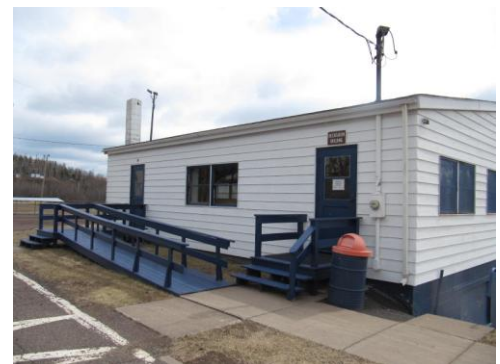
- A. **B2020 – Exterior Windows:** System was installed in 1950 and are in poor condition. Renewal Cost: \$17,797.
- B. **B2030 – Exterior Doors:** System was installed in 1950. Renewal Costs: \$ 9,769.

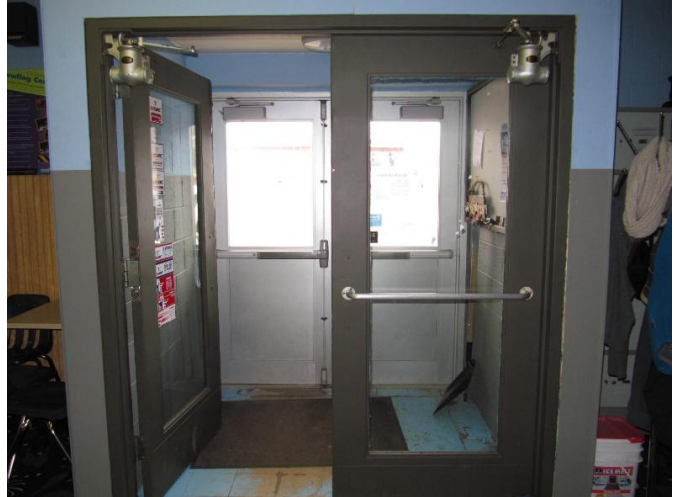
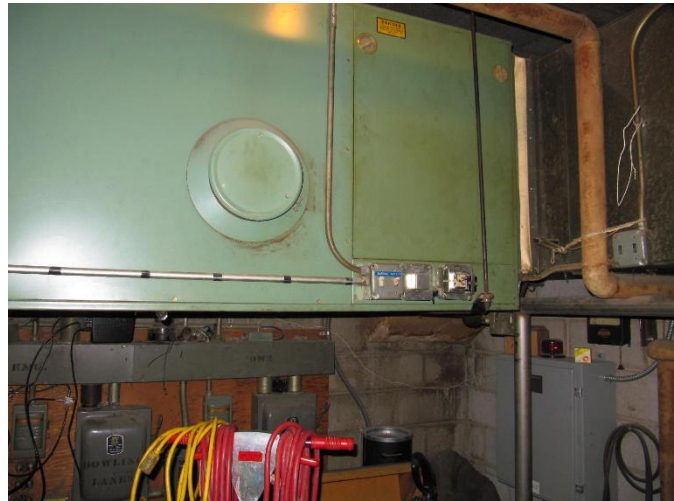
D. **D2020 – Domestic Water Distribution –** Water heater – Gas – 40 gallon. Installed in 2006. Renewal Cost: \$4,259.

E. **D3050 – Terminal and Package Units –** 2 Rooftop Unitary AC – Cooling w/Gas heat installed in 1998. Renewal Cost: \$89,890.

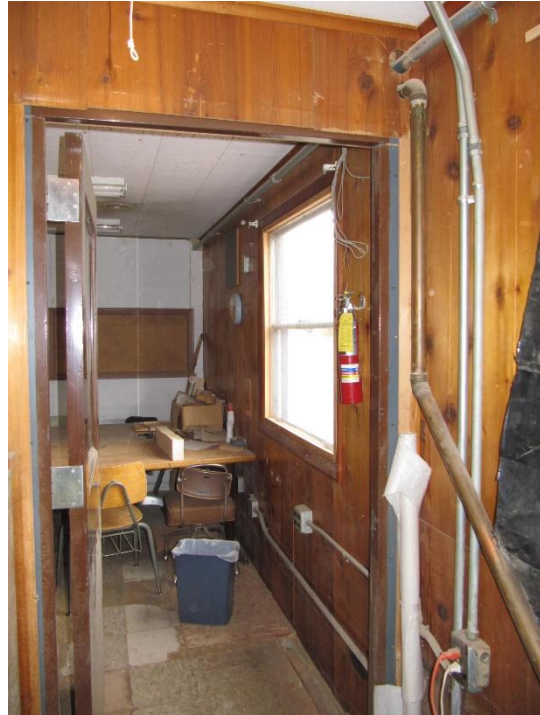
- C. **D2020 – Domestic Water Distribution** – System installed in 1950. Renewal Costs: \$15,514
- D. **D2010 – Plumbing Fixtures** – Restroom Fixtures – Standard. Were installed in 1950. Renewal Costs; \$6,158.
- E. **D2030 - Sanitary Waste:** System installed in 1950. Renewal Costs: \$16,132.
- F. **D5010 - Electrical Service and Distribution:** System installed in 1950. Renewal Costs: \$17,875.

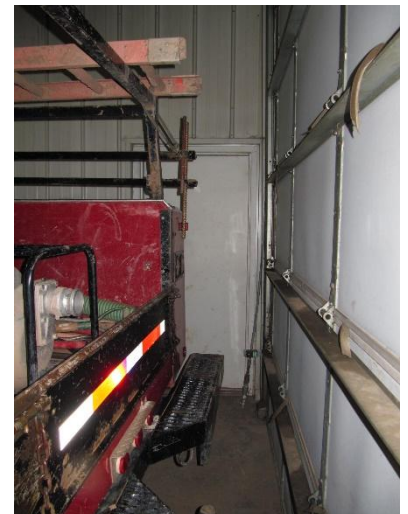
- A. **B2020 – Exterior Windows:** System was installed 1982. Renewal Cost: \$5,733.
- B. **B2030 Exterior Overhead Sectional Doors:** System was installed in 1982. Renewal costs: \$13,914.

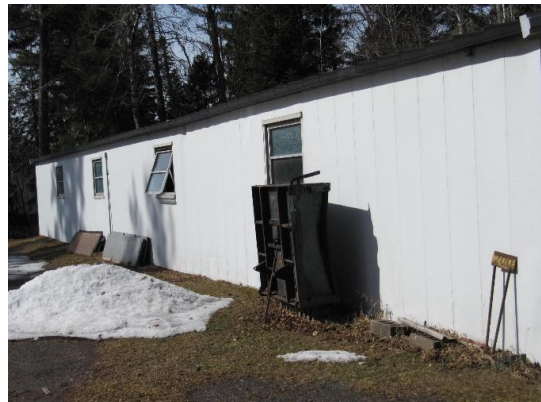
- A. **B2020 – Exterior Windows:** System was installed in 1957. Renewal Cost: \$4,300.
- B. **B2030 – Exterior Doors:** System was installed in 1957. Renewal Cost: \$6,844.
- C. **Substructure – Slab on Grade-** Installed in 1957. Erosion underneath slab. Renewal Cost - \$1,180

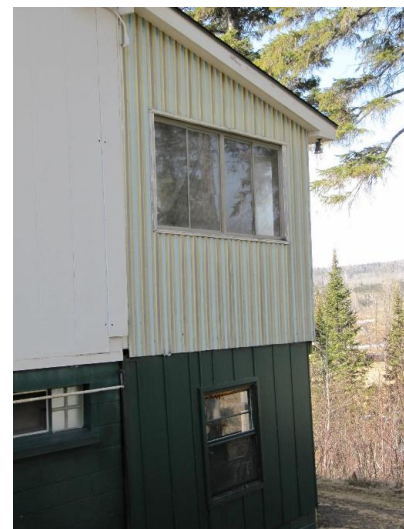
- A. **B2010 Exterior Walls:** Wood and metal siding was installed in 1957 and are in poor

condition. Glass block was installed in 1957.

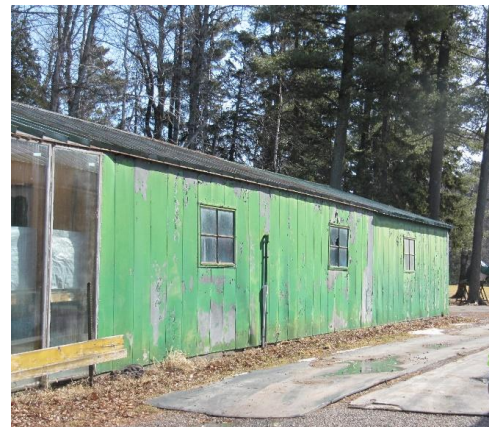
- A. **B30 - Roofing:** Metal roof System was installed in 1957 and is in poor condition. Renewal Cost: \$14,729.
- B. **B2020 – Exterior Windows:** Metal windows and translucent panels were installed in 1957 and are in poor condition. Renewal Cost: \$7,287.
- C. **B2030 – Exterior Door:** One metal door was installed in 1957 and is in poor condition. Renewal Cost: \$2,705.
