City Facilities and Infrastructure

As part of the existing conditions analysis for the Comprehensive Plan, CR-Building Performance Specialists, Inc. worked with the City of Silver Bay to develop a comprehensive Facility Conditions Assessment (FCA) of all the City's building assets, excluding site amenities and process equipment.

City of Silver Bay Comprehensive Plan

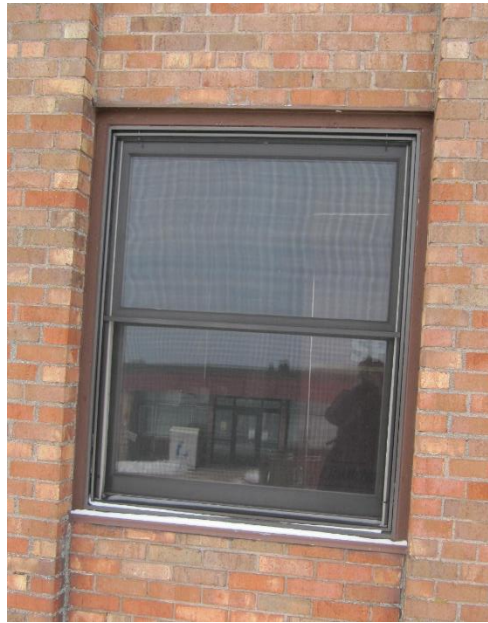
- B. **B2020 – Exterior Windows:** System was installed in 1986.
Renewal Cost: \$4,728.

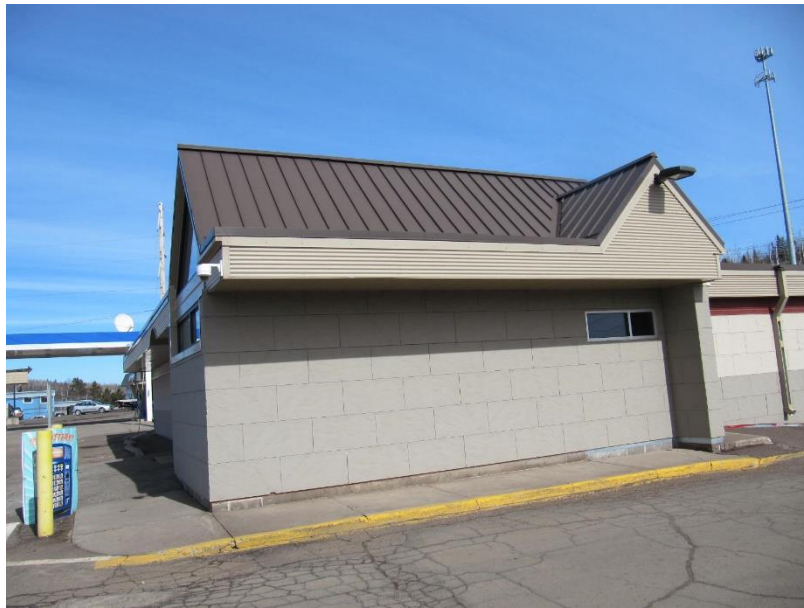
- A. **B30 - Roofing:** The system that was installed in 1977 is in poor condition. Supporting documentation of past repairs or roof replacement were not available. Renewal Cost: \$107,867.
- B. **B2020 – Domestic Water Distribution:** System was installed in 1977, both distribution system and water heater and are in poor condition. Renewal Cost: \$24,102.

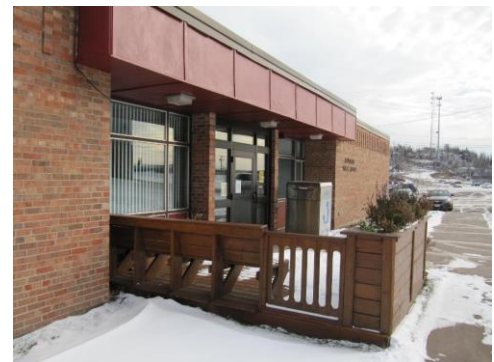
- A. **B30 - Roofing:** Current System was installed in November 1989 and is in poor condition. Supporting documentation of past repairs or roof replacement was not available. Renewal Cost: \$45,196
- B. **B2020 – Domestic Water Distribution:** System was installed in 1967 and is in poor condition. Renewal Cost: \$20,261

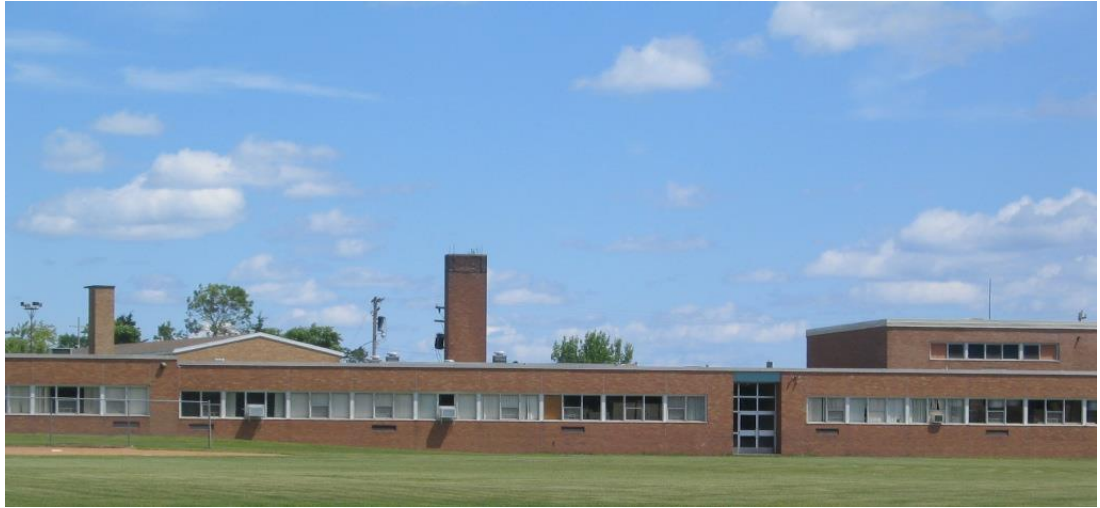
- A. **B30 - Roofing:** System was installed in 1962 with numerous repairs and is in poor condition. Supporting documentation of

past repairs or roof replacement were not available. Renewal Cost: \$1,029,345.

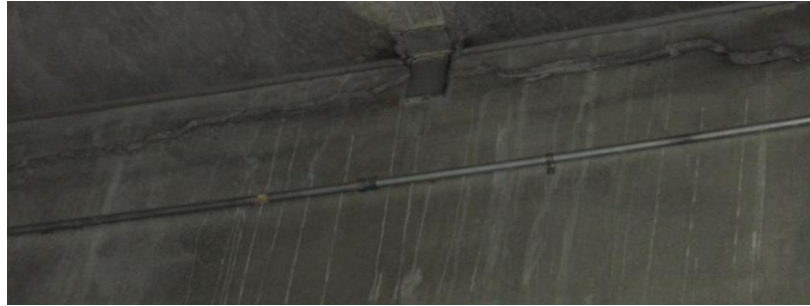
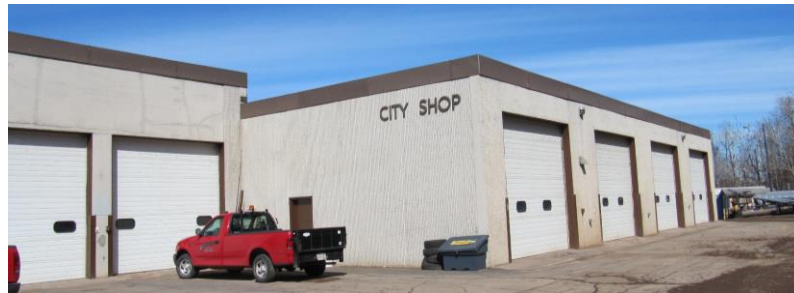
- B. **B10 - Superstructure:** System was installed in 1978. There are signs of inadequate subsurface soil bearing capacity. It is causing movement and premature failure of the structural wall system. It is recommended that a study be conducted to determine the type of repair that is needed to fix this deficiency. Structural Integrity Study Cost: \$5,800

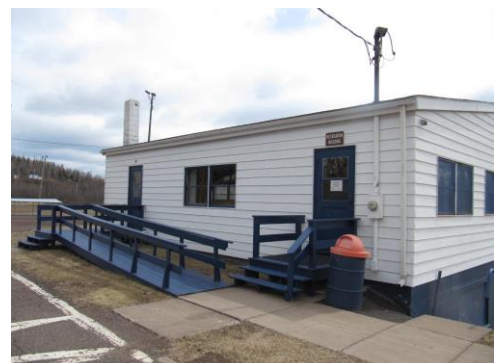
- A. **B2020 – Exterior Windows:** System was installed in 1950 and are in poor condition. Renewal Cost: \$17,797.
- B. **B2030 – Exterior Doors:** System was installed in 1950. Renewal Costs: \$ 9,769.

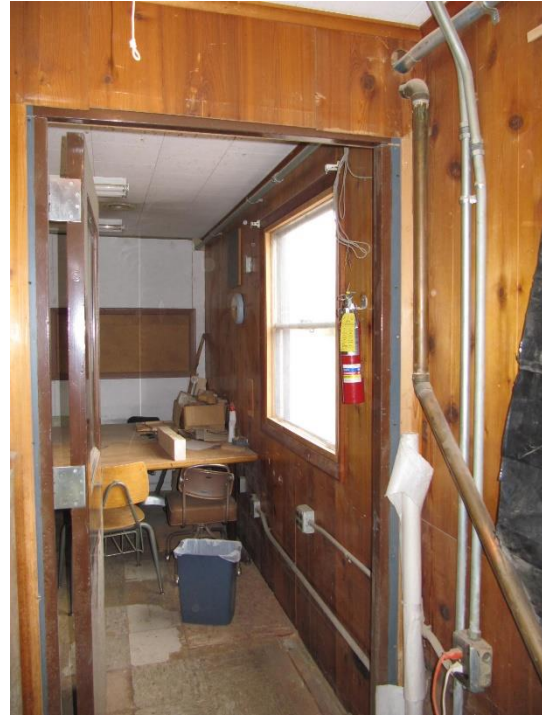
- C. **D2020 – Domestic Water Distribution** – System installed in 1950. Renewal Costs: \$15,514
- D. **D2010 – Plumbing Fixtures** – Restroom Fixtures – Standard. Were installed in 1950. Renewal Costs; \$6,158.
- E. **D2030 - Sanitary Waste:** System installed in 1950. Renewal Costs: \$16,132.
- F. **D5010 - Electrical Service and Distribution:** System installed in 1950. Renewal Costs: \$17,875.

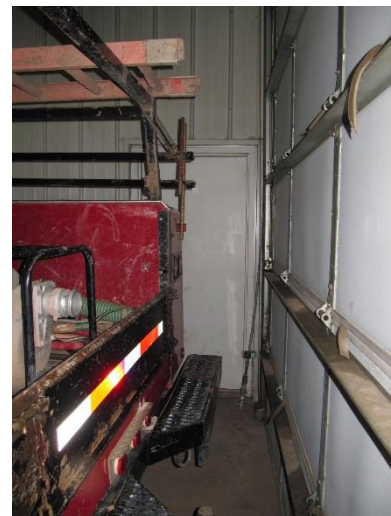
- A. **B2020 – Exterior Windows:** System was installed 1982. Renewal Cost: \$5,733.
- B. **B2030 Exterior Overhead Sectional Doors:** System was installed in 1982. Renewal costs: \$13,914.

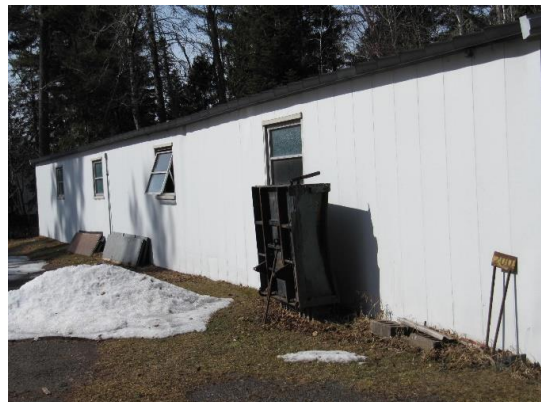
- A. **B2020 – Exterior Windows:** System was installed in 1957. Renewal Cost: \$4,300.
- B. **B2030 – Exterior Doors:** System was installed in 1957. Renewal Cost: \$6,844.
- C. **Substructure** – Slab on Grade- Installed in 1957. Erosion underneath slab. Renewal Cost - \$1,180

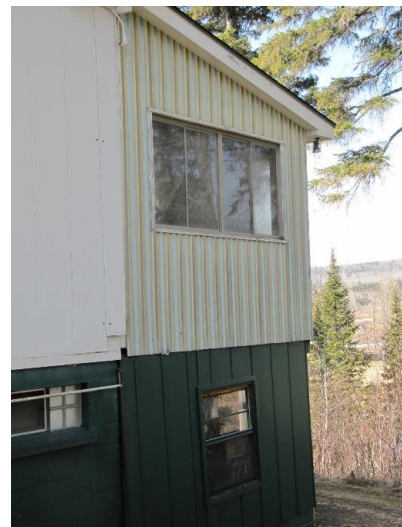
- A. **B2010 Exterior Walls:** Wood and metal siding was installed in 1957 and are in poor

condition. Glass block was installed in 1957. Renewal Cost: \$3,070.

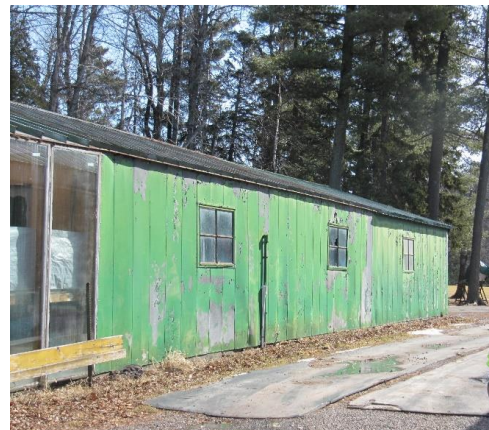
- A. **B30 - Roofing:** Metal roof System was installed in 1957 and is in poor condition. Renewal Cost: \$14,729.
- B. **B2020 – Exterior Windows:** Metal windows and translucent panels were installed in 1957 and are in poor condition. Renewal Cost: \$7,287.
- C. **B2030 – Exterior Door:** One metal door was installed in 1957 and is in poor condition. Renewal Cost: \$2,705.
