City of Silver Bay Comprehensive Plan

Facility Condition Index Report

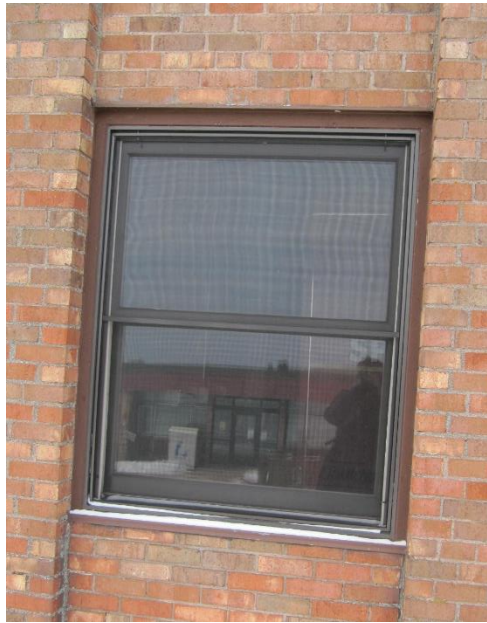
- B. **B2020 – Exterior Windows:** System was installed in 1986.
Renewal Cost: \$4,728.

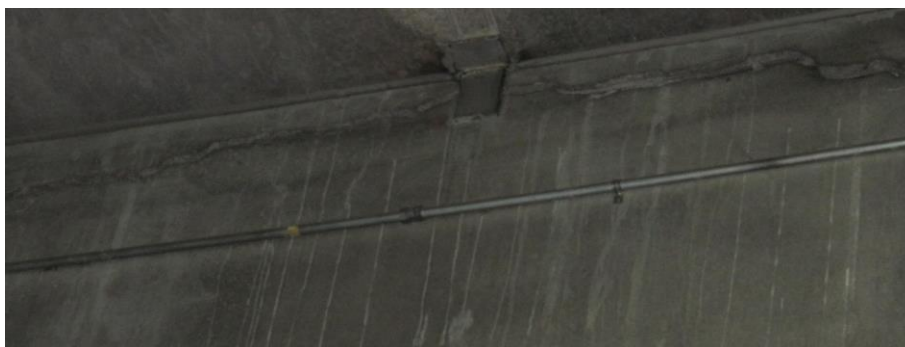
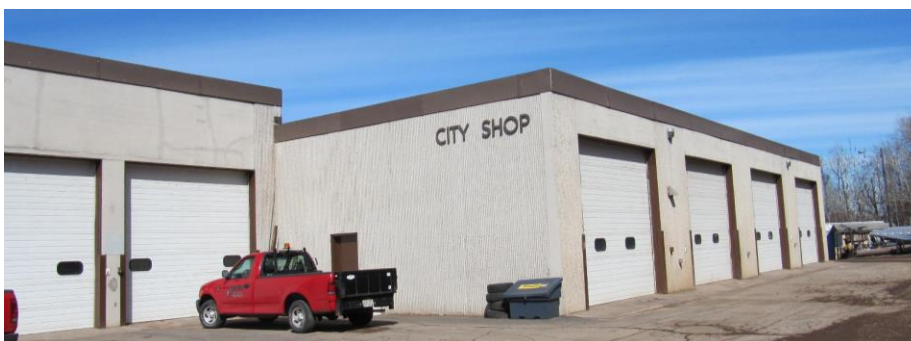
- B. **B10 - Superstructure:** System was installed in 1978. There are signs of inadequate subsurface soil bearing capacity. It is causing movement and premature failure of the structural wall system. It is recommended that a study be conducted to determine the type of repair that is needed to fix this deficiency. Structural Integrity Study Cost: \$5,800

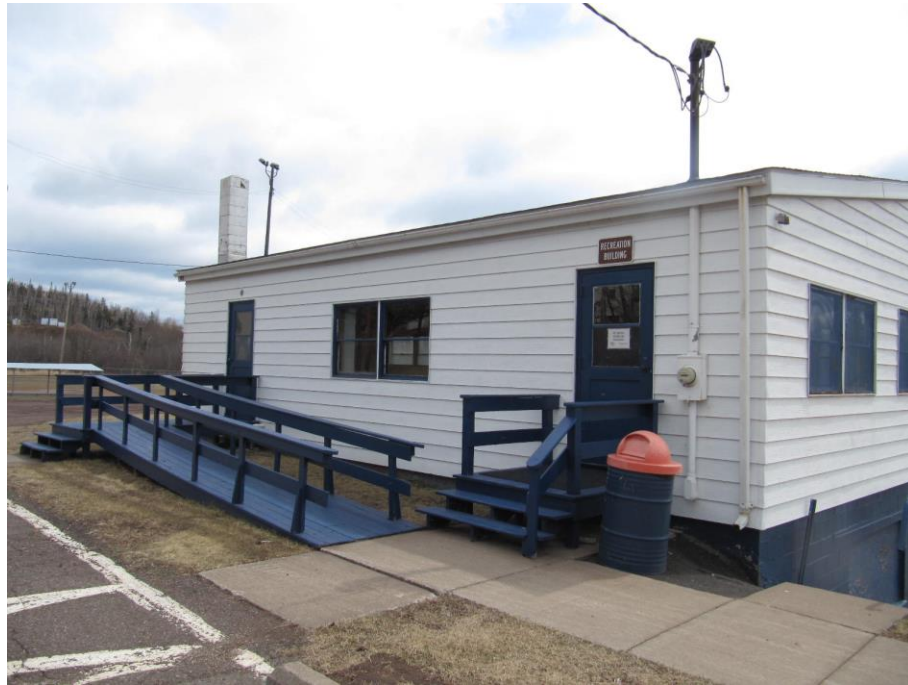
- B. **B2030 – Exterior Doors:** System was installed in 1950. Renewal Costs: \$ 9,769.

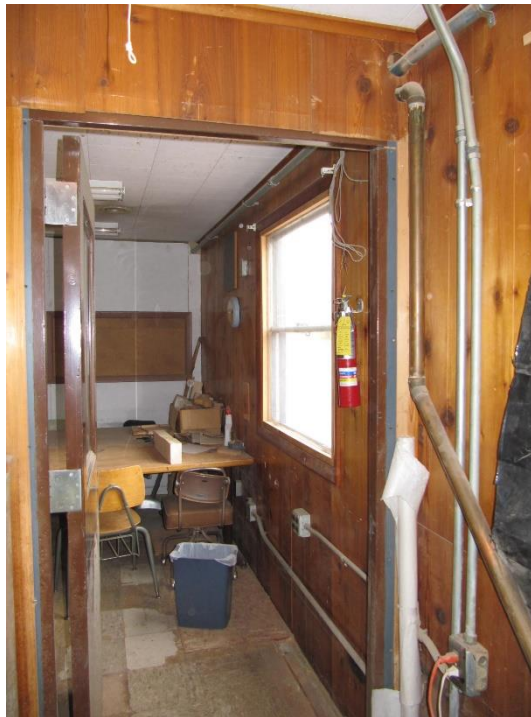
- A. **B2030 Exterior Doors:** system installed in 1988. Renewal costs: \$8,320.
- B. **B2020 – Exterior Windows:** System was installed in 1988. Renewal Cost: \$6,405.

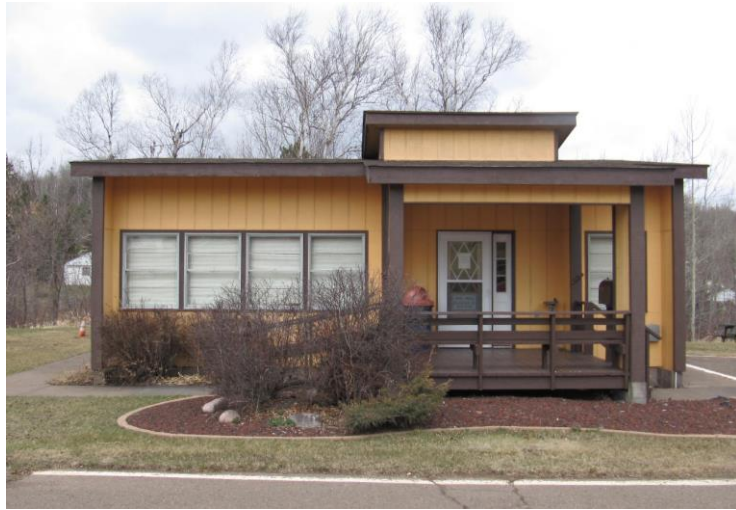
- A. **B2030- Exterior Doors:** System was installed in 1981. Renewal Costs: \$9,769.
- B. **B2020 – Exterior Windows:** System was installed in 1981. Renewal Cost: \$3,359.

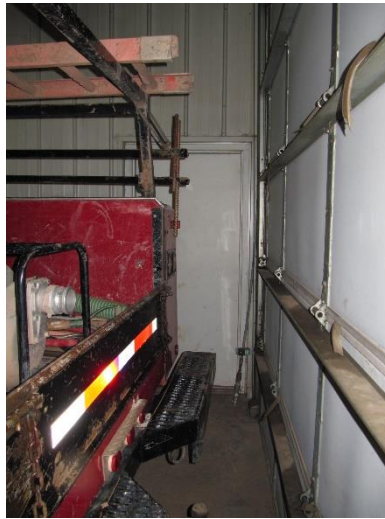
- A. **B2020 – Exterior Windows:** System was installed 1982. Renewal Cost: \$5,733.
- B. **B2030 Exterior Overhead Sectional Doors:** System was installed in 1982. Renewal costs: \$13,914.

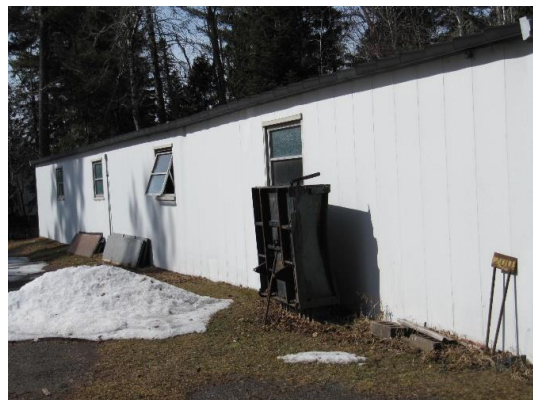
- A. **B2020 – Exterior Windows:** System was installed in 1957.
Renewal Cost: \$4,300.

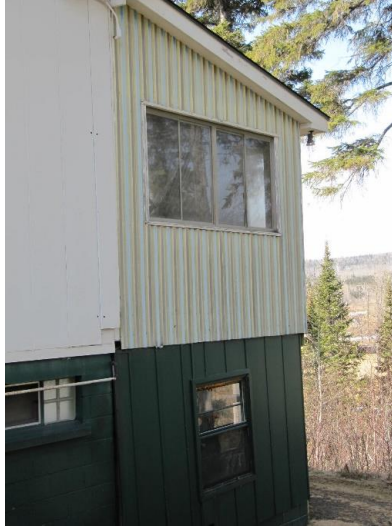
- A. **B2010 Exterior Walls:** Wood and metal siding was installed in 1957 and are in poor condition. Glass block was installed in 1957. Renewal Cost: \$3,070.

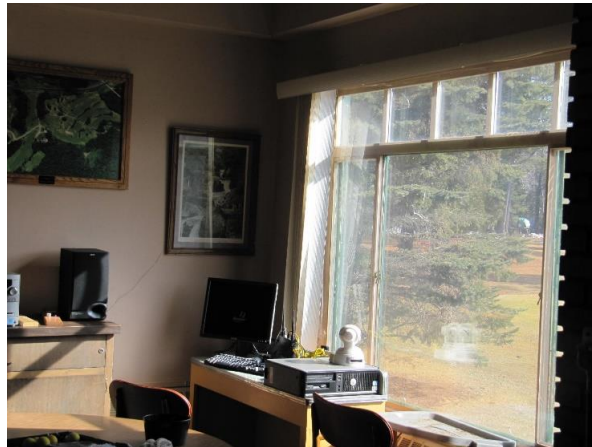
- B. **B2020 – Exterior Windows:** System was installed in 1957 and 1990 and is in poor condition. Renewal Cost: \$44,818.

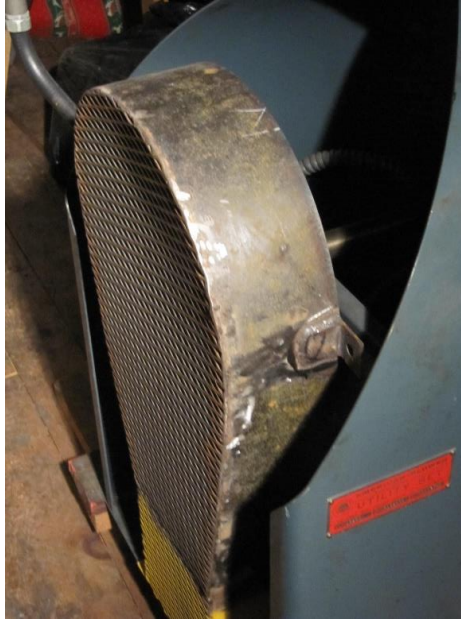
- F. **D3040 – Exhaust Systems:** System was installed in 1957. It is in poor condition. Renewal Cost: \$18,861.

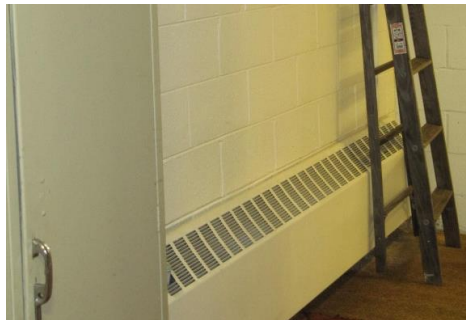
- G. **D3040 – Perimeter Heat System:** Hydronic System was installed in 1957. Renewal Cost: \$ 52,436.

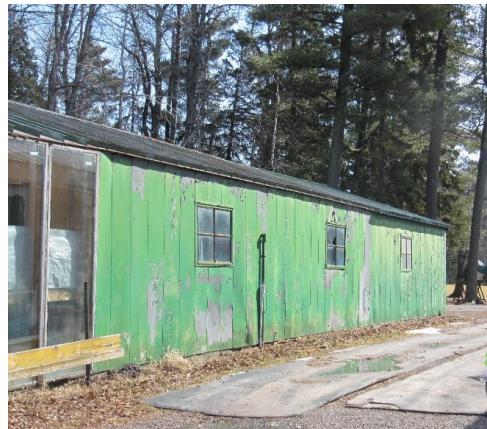
- A. **B30 - Roofing:** Metal roof System was installed in 1957 and is in poor condition. Renewal Cost: \$14,729.
- B. **B2020 – Exterior Windows:** Metal windows and translucent panels were installed in 1957 and are in poor condition. Renewal Cost: \$7,287.
